THE UNITED STATES  
STRATEGIC BOMBING SURVEY

# THE ELECTRIC POWER INDUSTRY OF JAPAN

(Plant Reports)

Electric Power Division

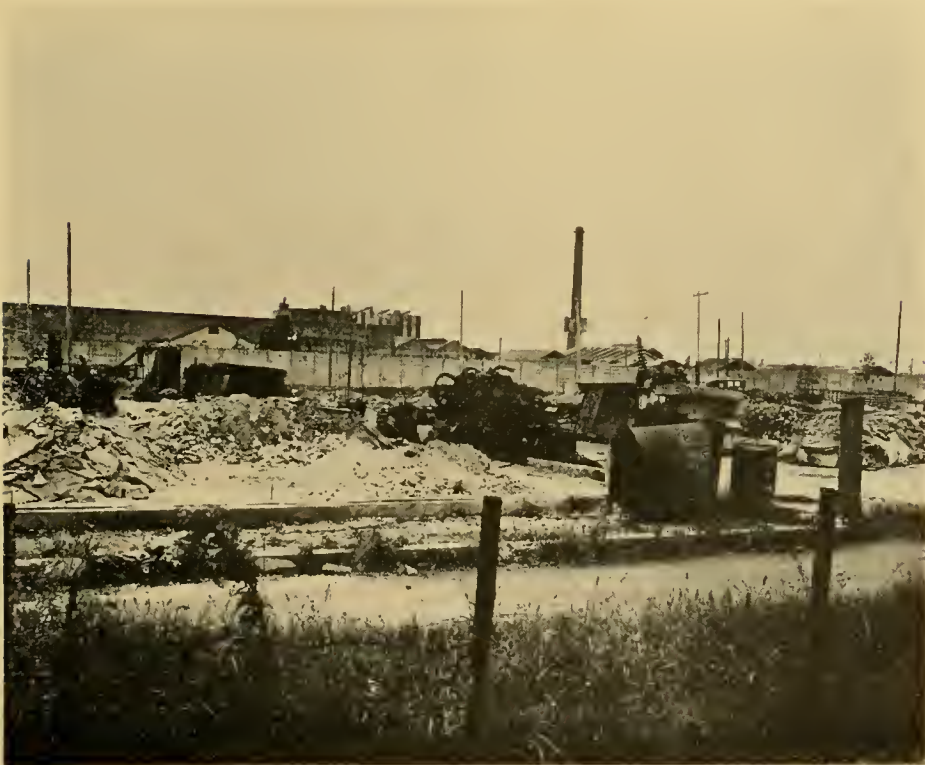
Photo 20—Rokugo—General view burned electrical storeroom adjacent to substation

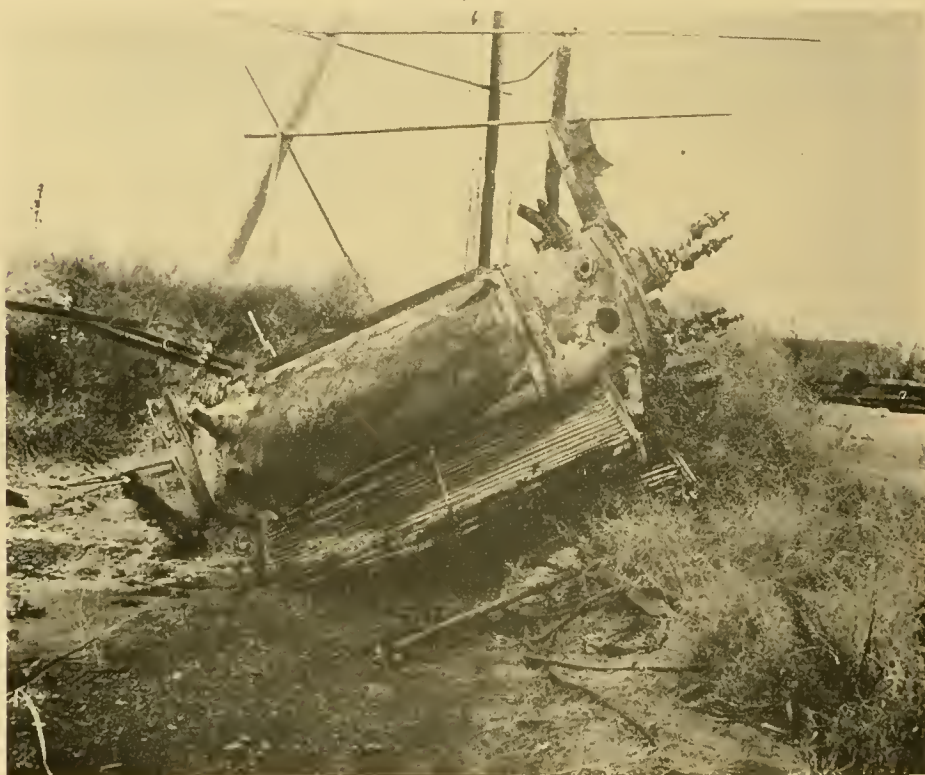
Mitsubishi factory as the primary target. Four bombs struck the station and completely ruined it. One bomb fell near, and another made a direct hit on the transformer bank (Exhibit B, photo 21), splitting the cases on the transformers, setting fire to the oil, and completely demolishing them beyond any possible repair. (Exhibit B, photos 21, 22, 23 and 24). Another made a direct hit on the group of oil circuit breakers, splitting the tanks, setting the oil on fire and completely ruining them. (Exhibit B, photo 25). Another hit near the 77-KV bus structure tore it up completely. This bomb apparently did not completely detonate as a portion of the casing was found in the crater. (Exhibit B, photo 26). This station was completely destroyed; the damage was greater than that at any other station seen that had been hit by high explosive bombs. The damage that was done with so few bombs was remarkable. No protective measures of any kind had been taken.

Photo 22—Taiko—Transformer No 1 of destroyed bank

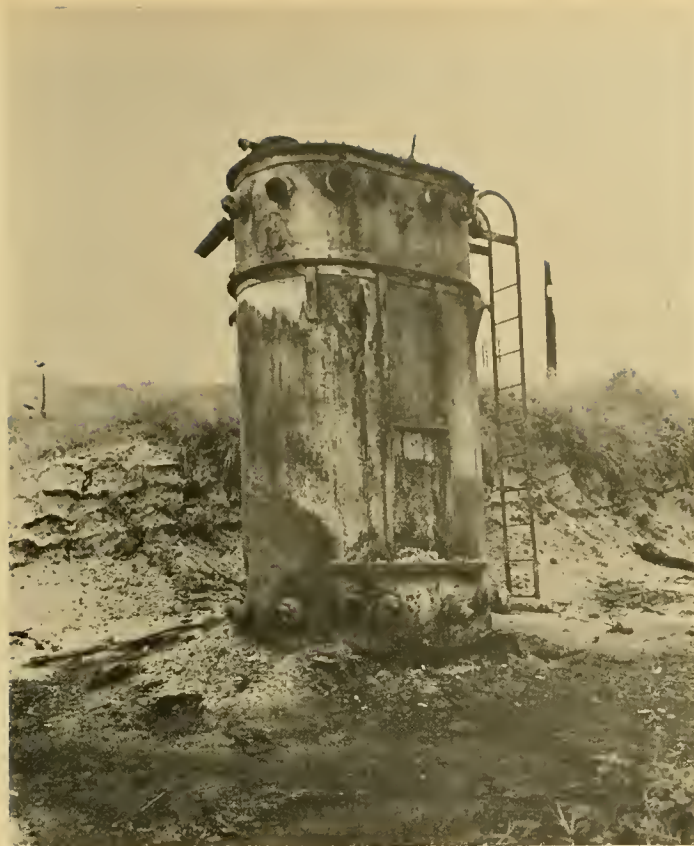
Photo 23—Taiko—Transformer No 2 of destroyed bank

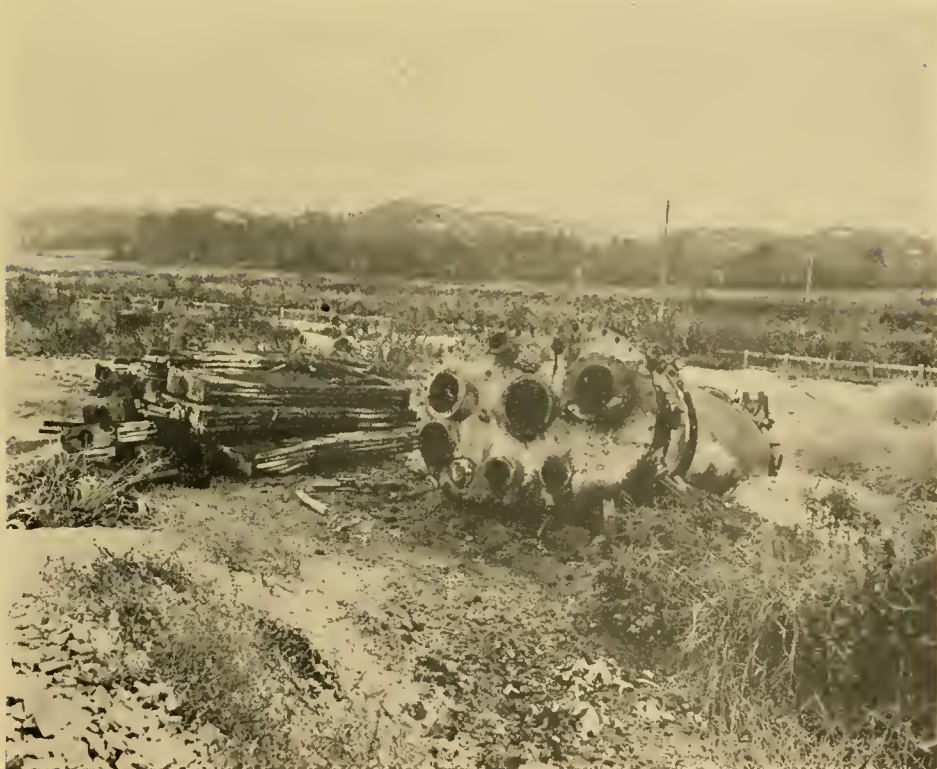
Photo 24—Taiko—Transformer No 3 of destroyed bank

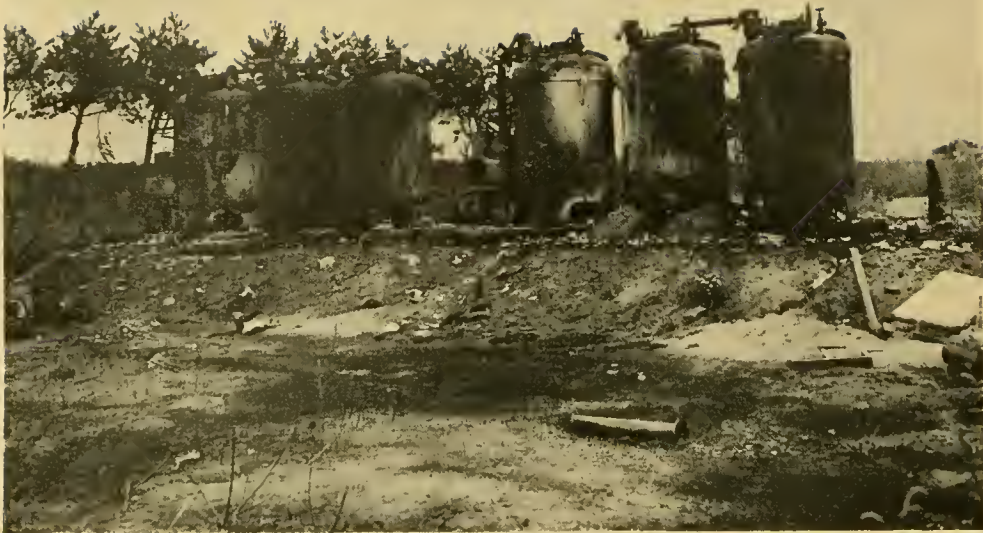
Photo 25—Taiko—Destroyed group of oil circuit breakers

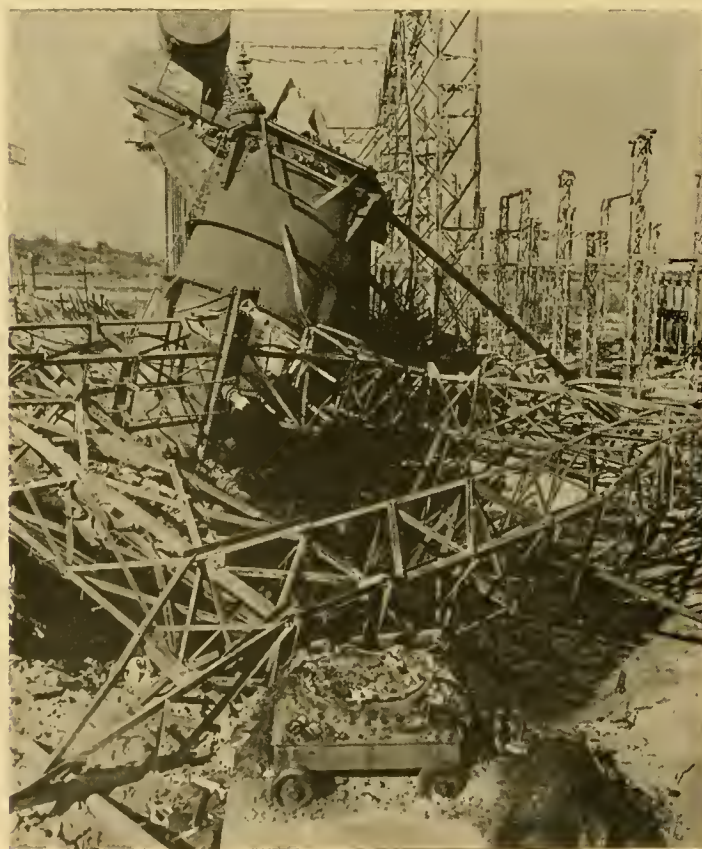
Photo 2—Bomb crater from direct hit at end of transformer bank

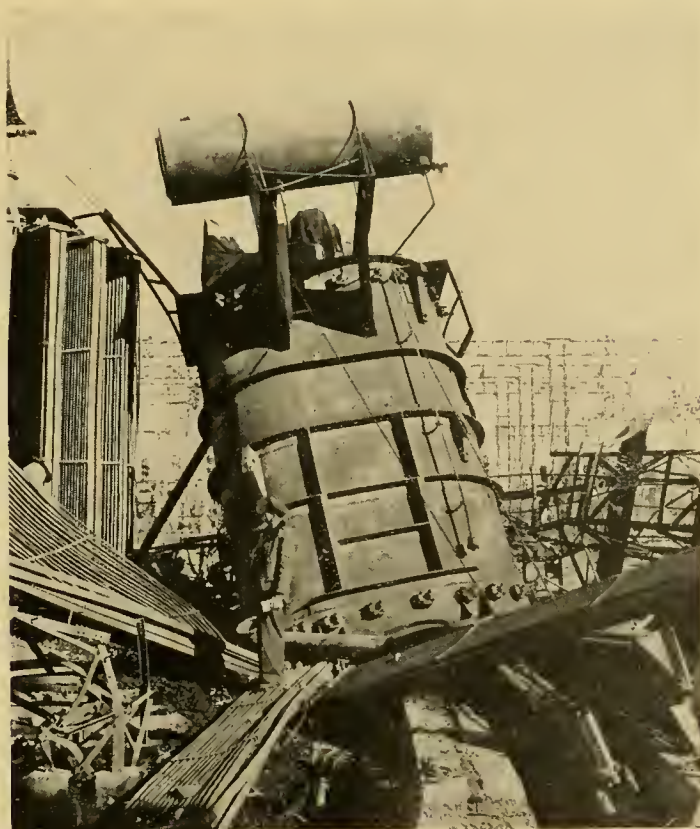
Photo 4—Damaged 20,000-KVA transformer  
(end transformer in photo 3)

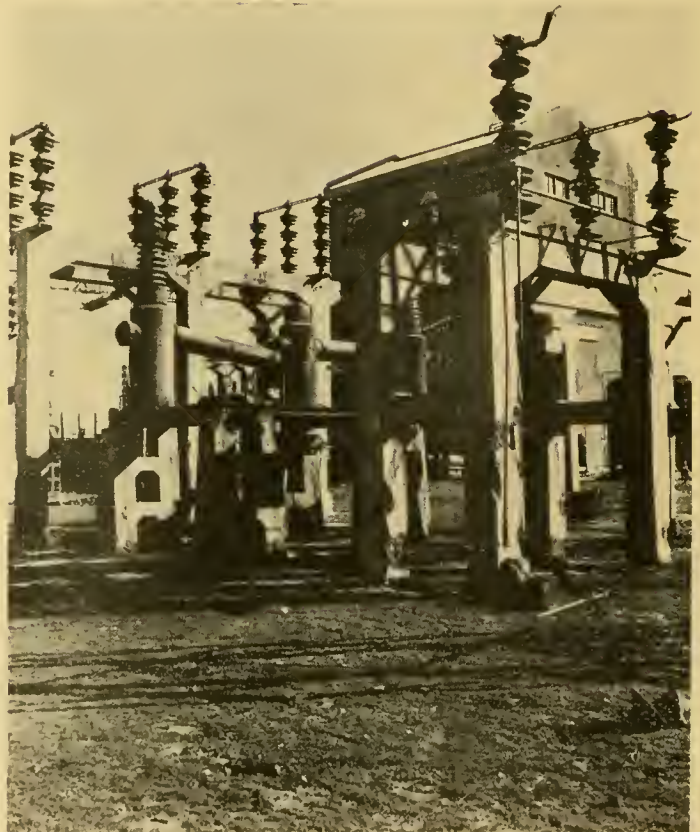
*One hit* in center of 154-KV bus structure completely demolished about half of this structure with all supports, and fragmentation damaged both the 154-KV air blast breakers and supporting structures. (Exhibit C, photos 6 and 7).

Photo 6—Damaged 154 KV air blast breaker.  
Note fragmentation marks

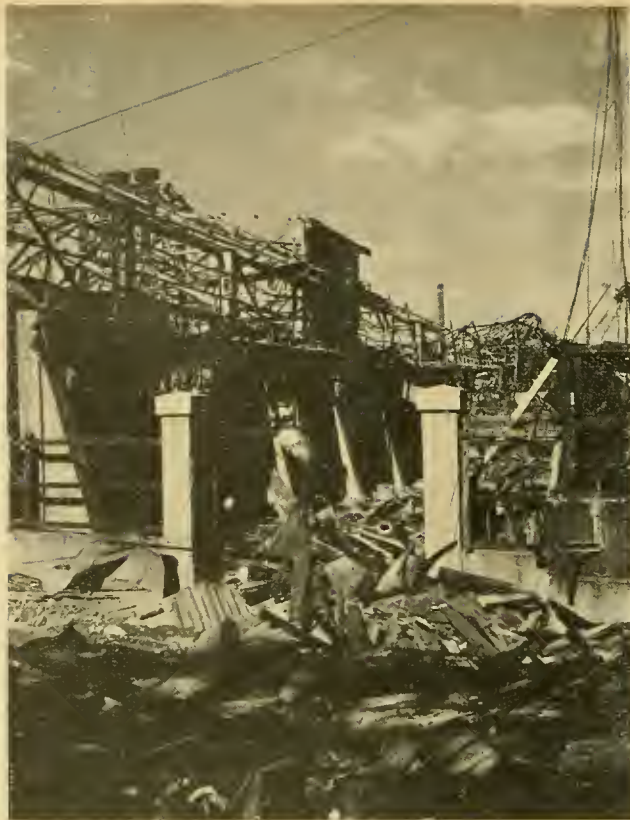
Photo 5—Sakurajima substation-view showing this substation at left and damaged industrial plant in background

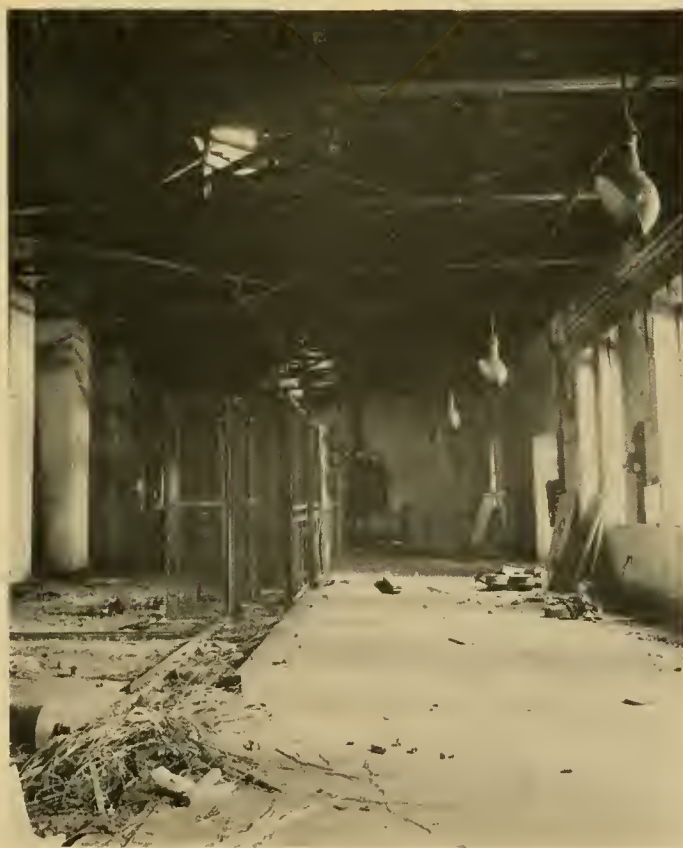
Photo 8—Dotombori substation-view showing damaged control panels and control wiring, part in foreground removed

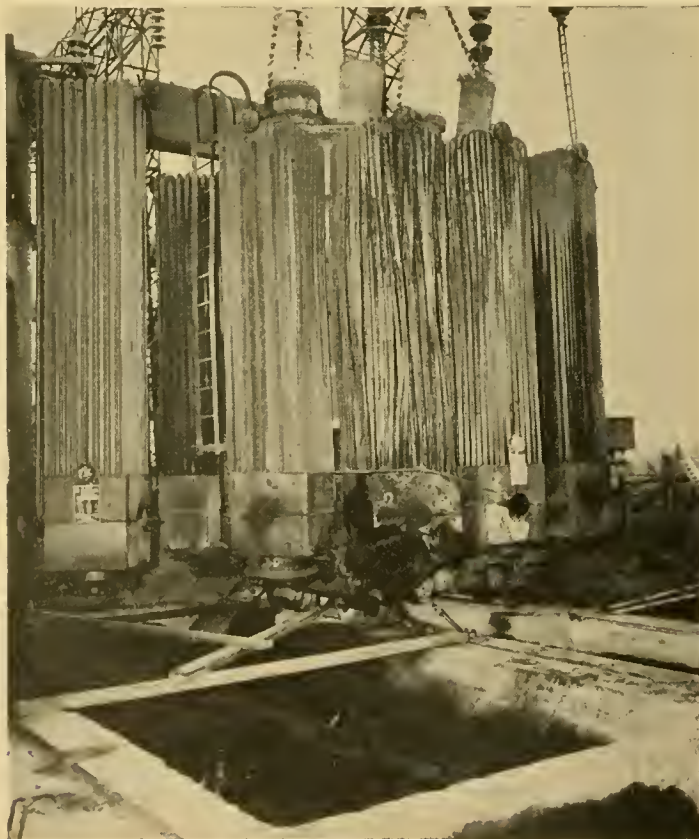
Photo 2—View showing damaged transformer in original position No 6

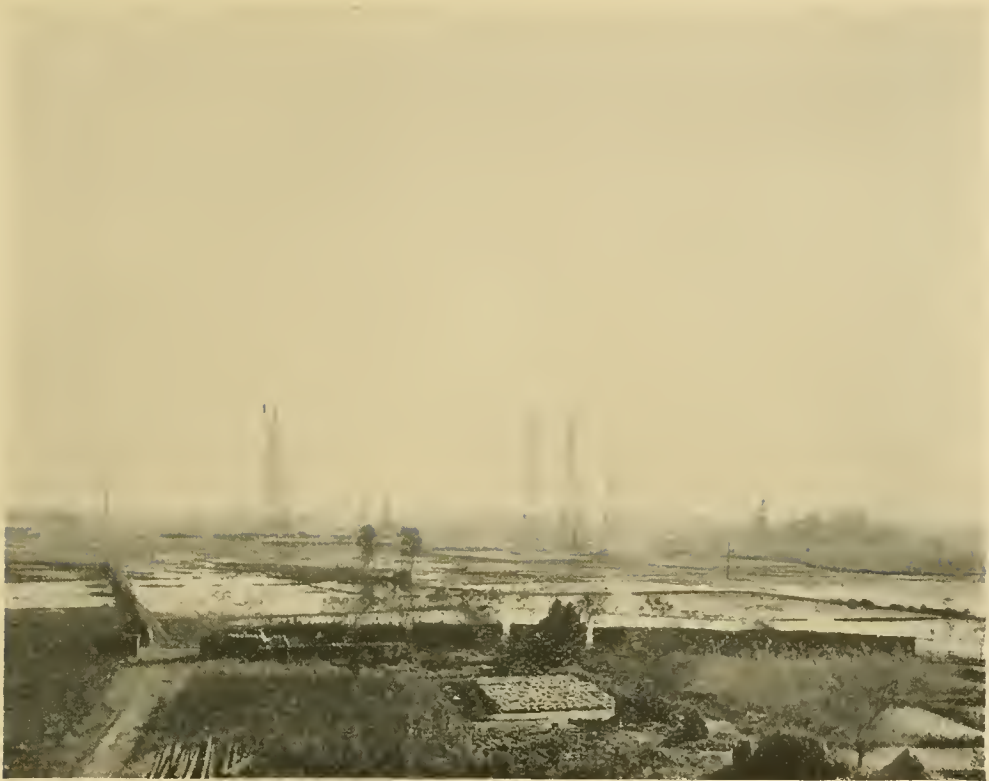
Photo 13—Keihoku substation—Area surrounding station

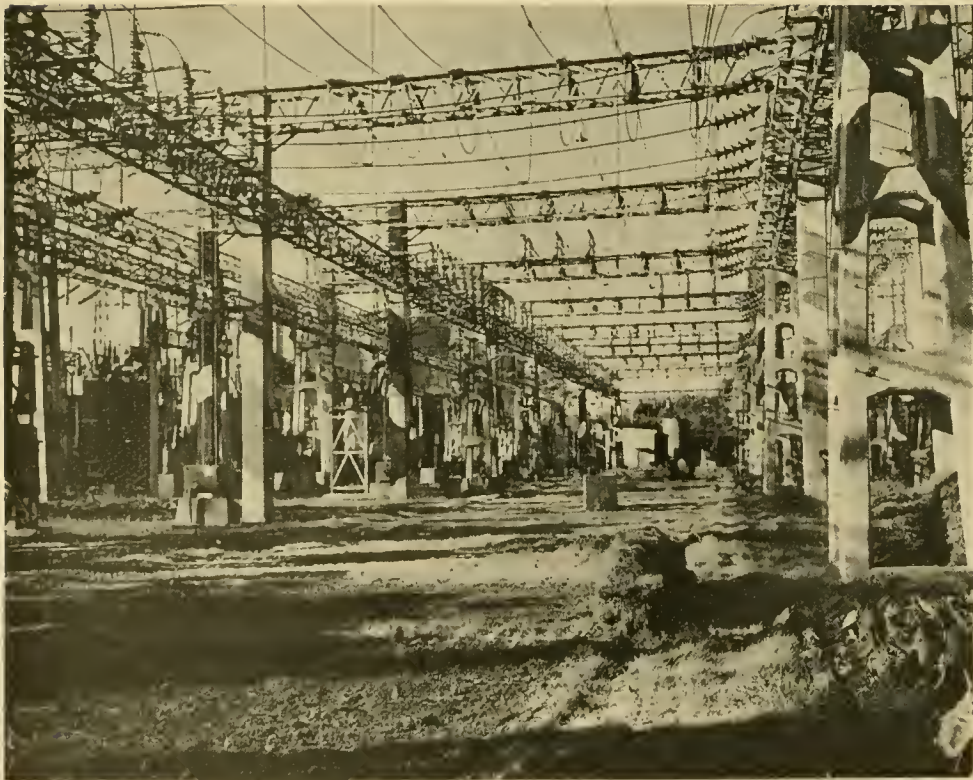
Photo 20—Wadabori substation—concrete upright supports

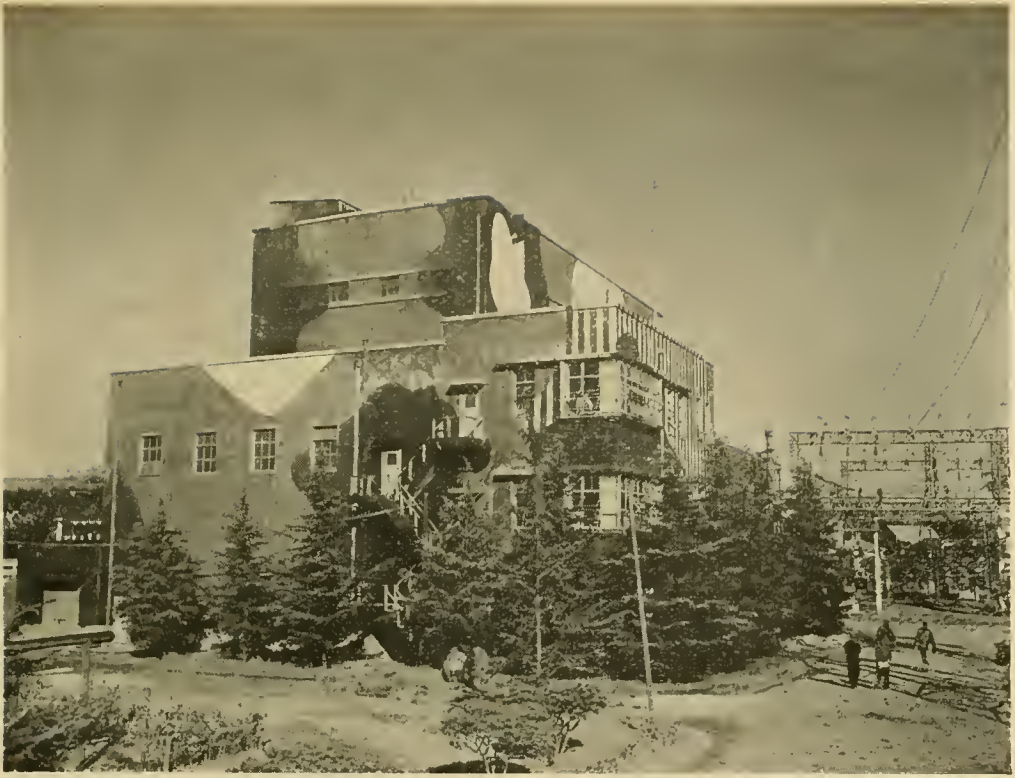
Photo 21—Wadabori substation—Control building

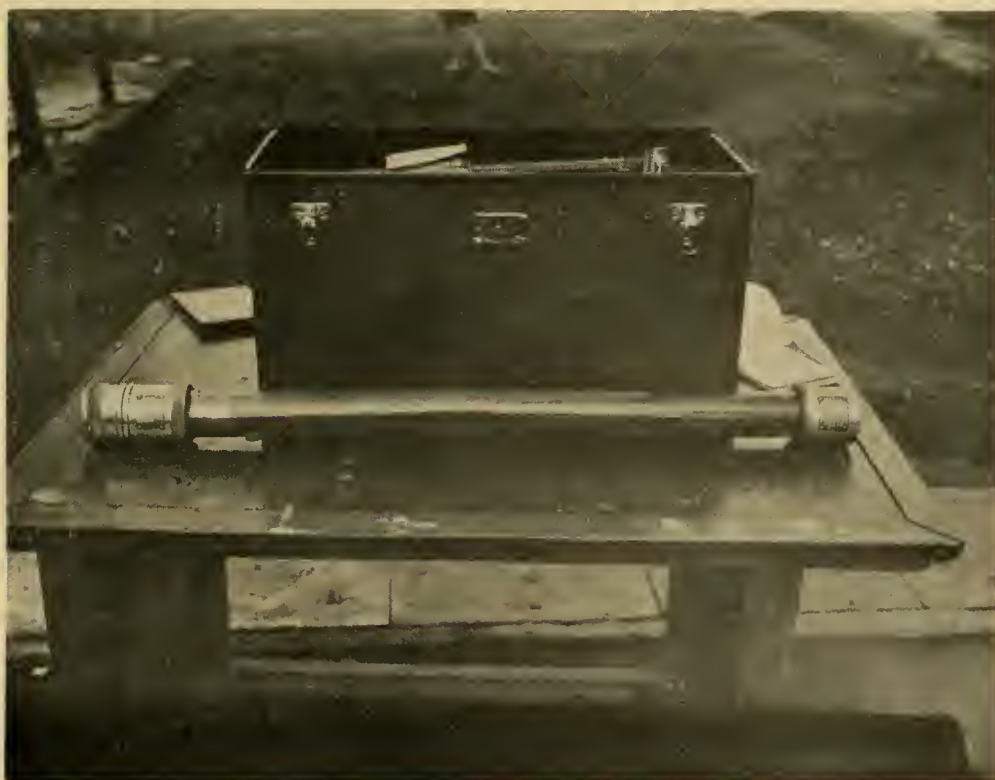
Photo 8—Chigasaki substation—Japanese copy of American manufactured liquid high voltage fuse

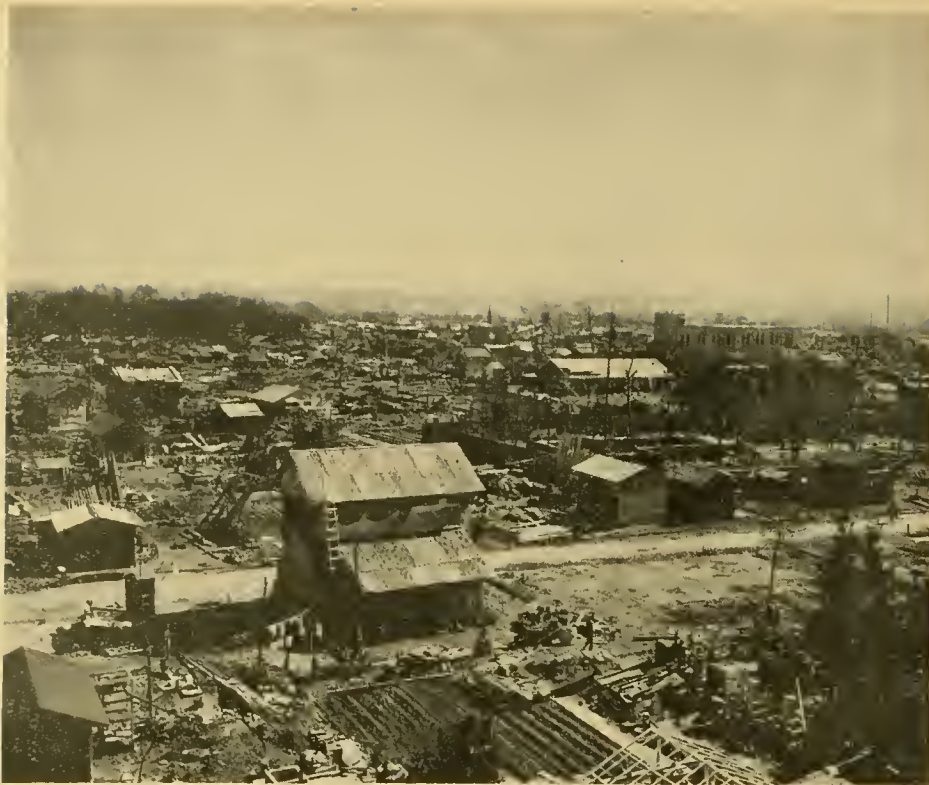
Photo 9—Hachioji substation—Area around the substation

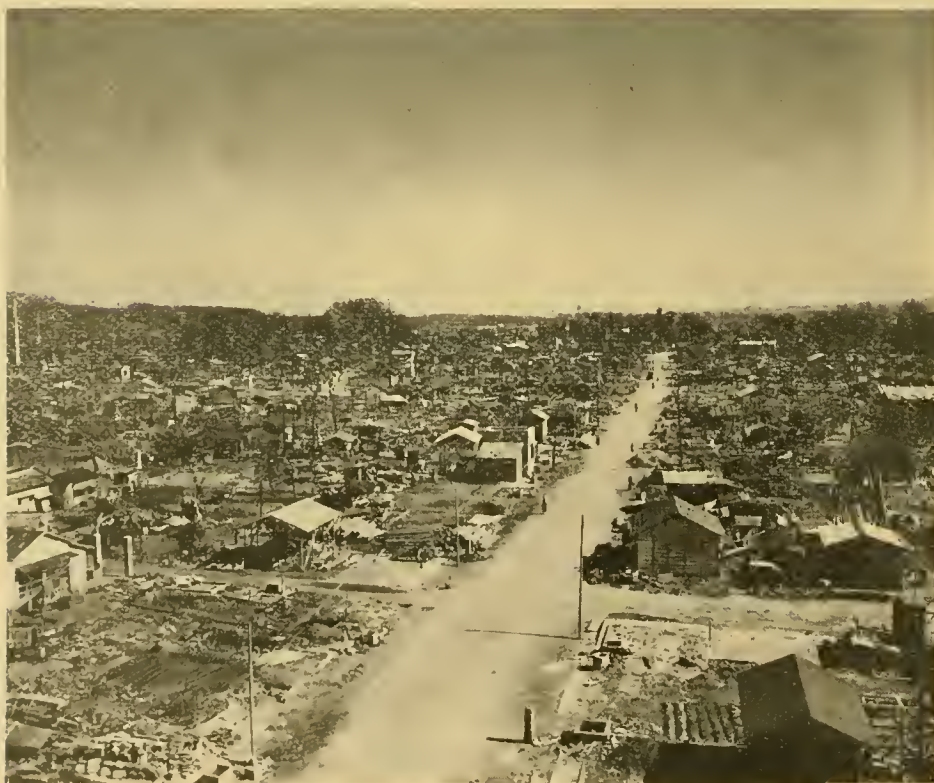
Photo 10—Hachioji substation—Area around station showing crowded, inflammable buildings.  
Buildings shown have been built since the area was destroyed by fire on 2 August 1945

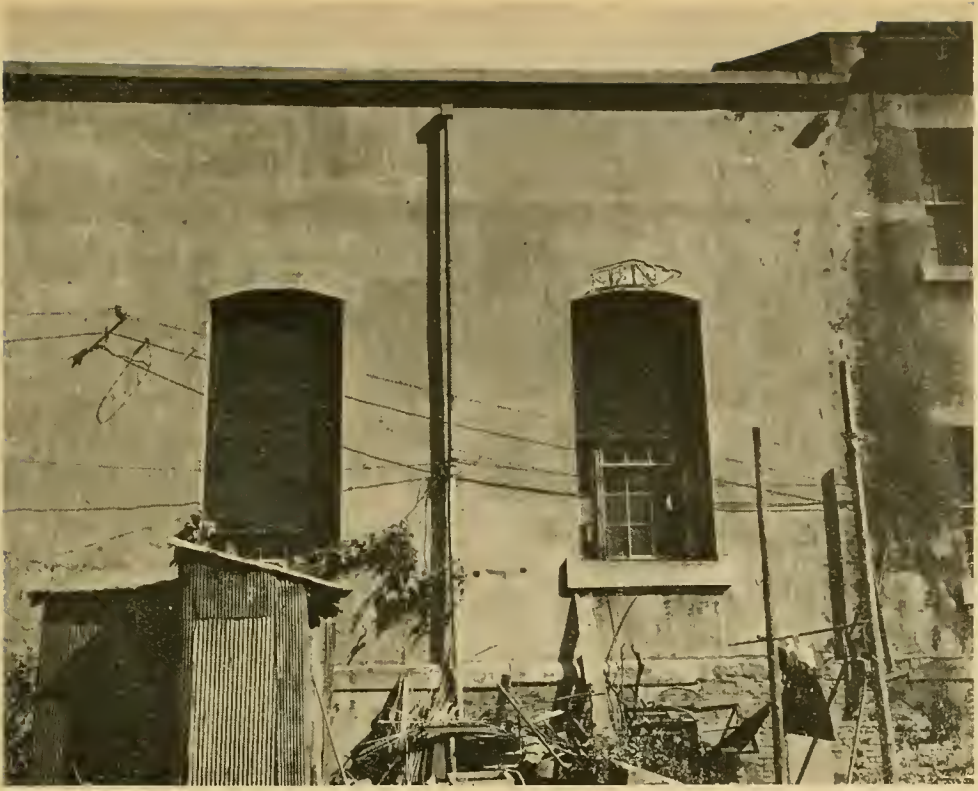
Photo 11—Hongincho substation—View showing metal window shutters installed to protect against fires during earthquake

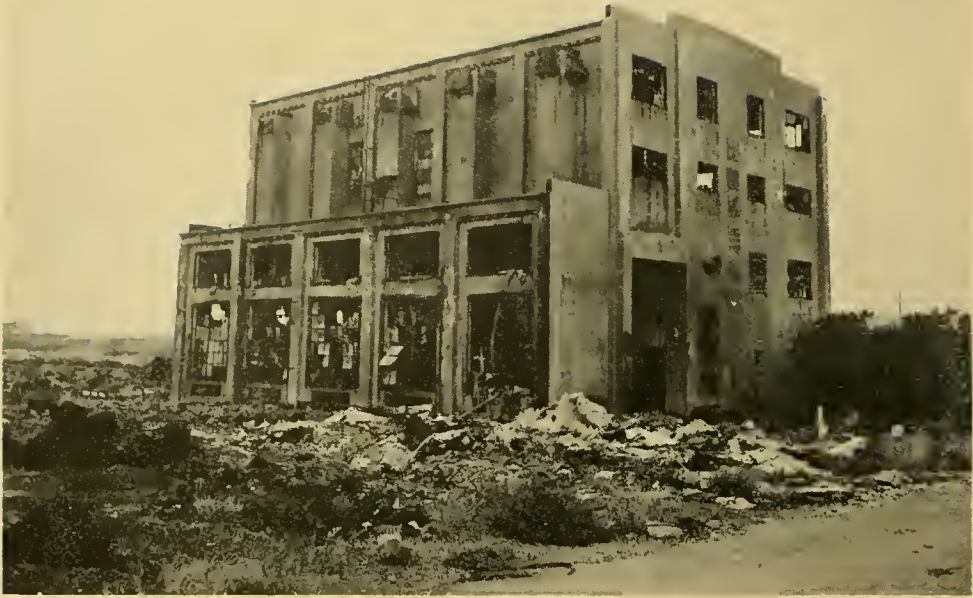
Photo 12—Jukkengawa substation—Front view of building—transformer room in foreground—  
spare transformers, stored in yard, also destroyed

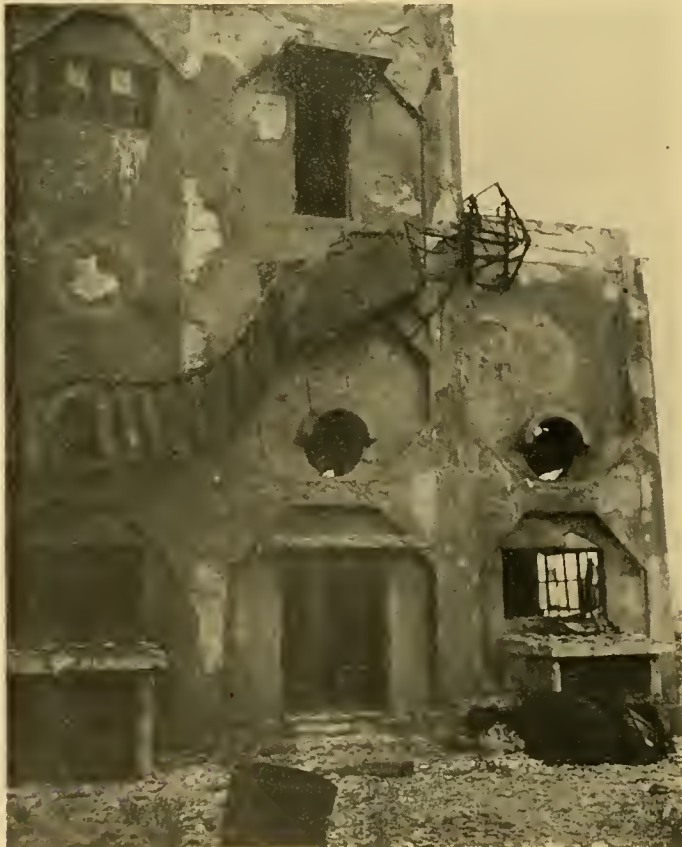
Photo 13—Jukkengawa substation—rear view of building, transformer room on right

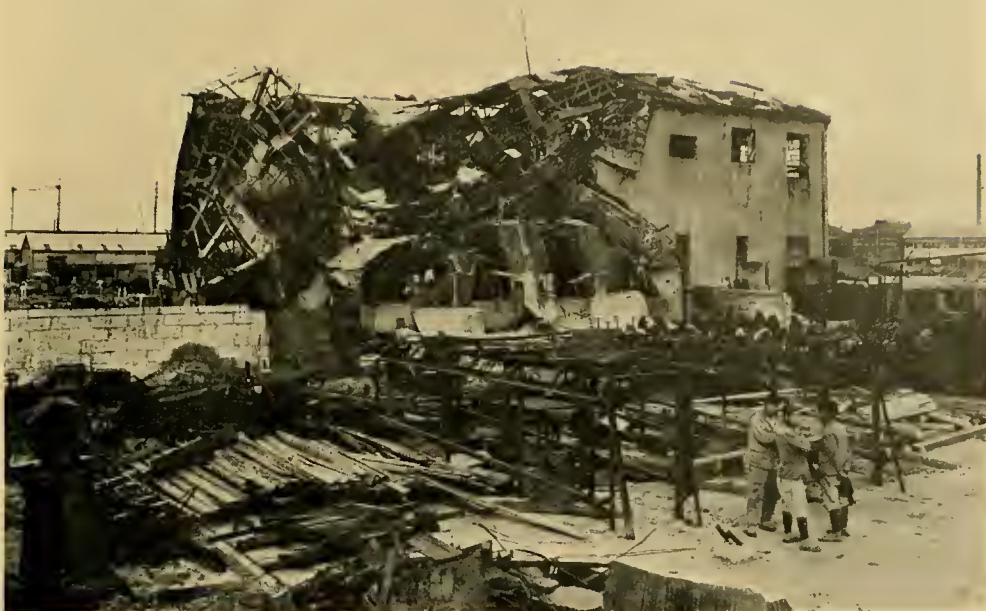
*Principal physical damage*—One of the incendiary bombs penetrated the transite roof and landed on the transformer floor near one of the transformers. The ensuing fire completely destroyed the transformers, all other electrical equipment, and the building. (Exhibit A, photos 21 and 22).

Photo 21—Nippori substation—General view of station. Incendiary bomb penetrated roof in center foreground

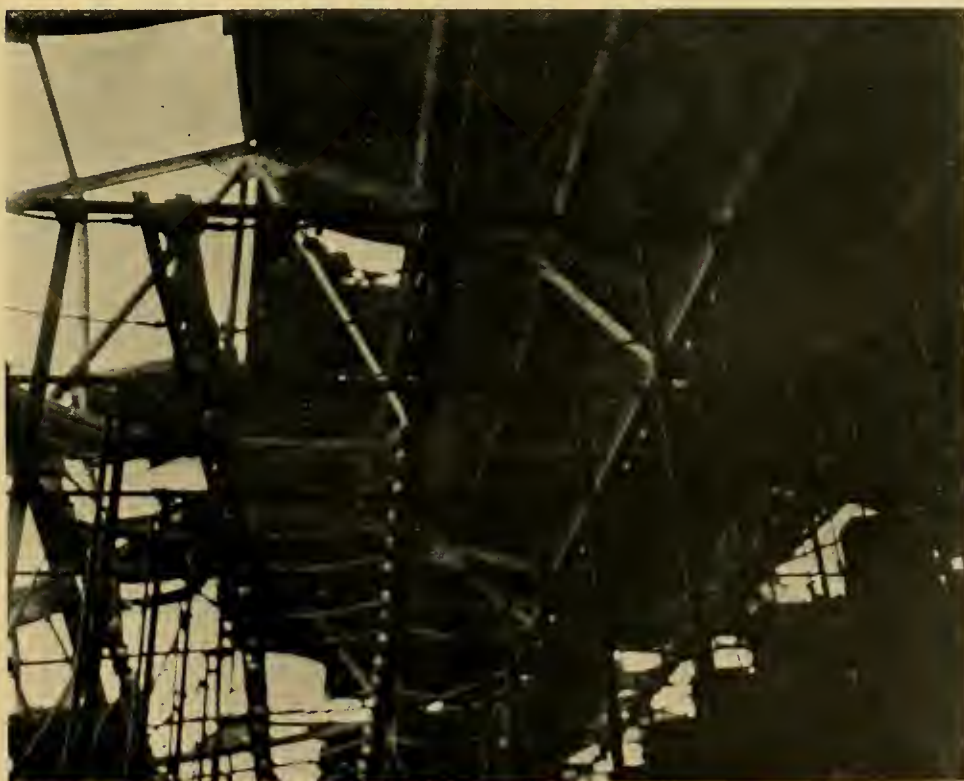
Photo 22—Nippori substation—View from inside switch room, second floor, to show hole in roof made by bomb

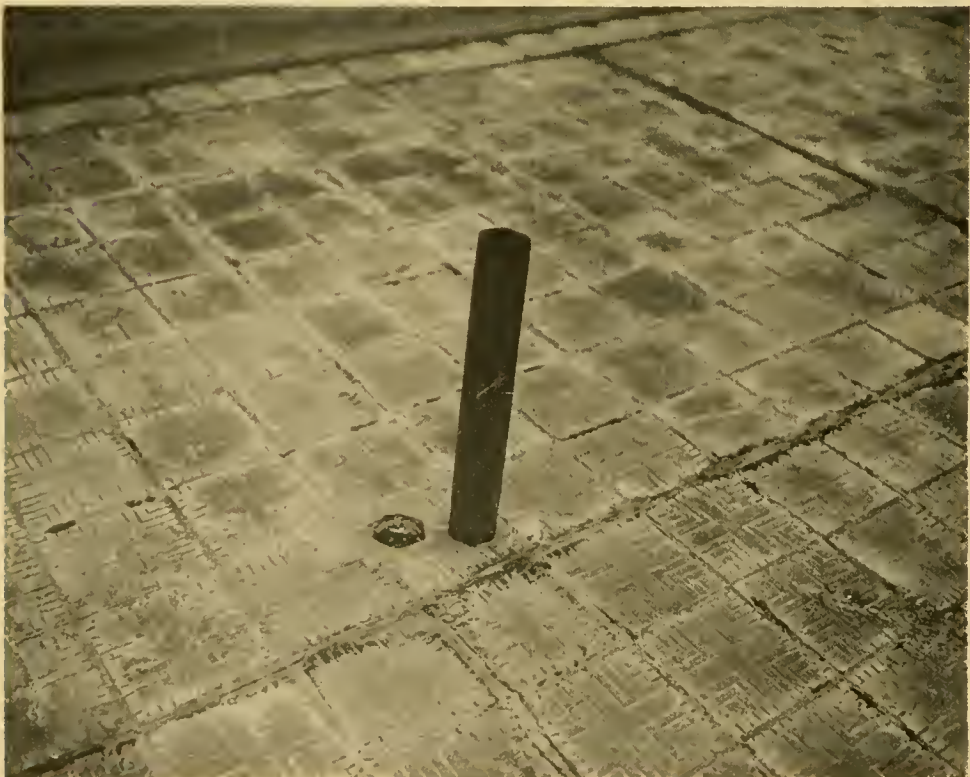
*Principal physical damage*—Six IBs landed on the roof but, because of the concrete construction, there was no penetration. The bombs were left to burn themselves out. In one case the bomb landed upright, and there is a perfect hexagon hole just through the surface of the concrete roof about one-quarter of an inch deep (Exhibit A, photo 24). There was no damage to the substation electrical equipment. The adjacent area was destroyed by fire, but since there were no windows on the sides of the building adjacent to the fire, it did not spread to the station.

Photo 24—Oshima substation—View of mark on concrete tile roof made by incendiary bomb.  
Empty incendiary case for comparison

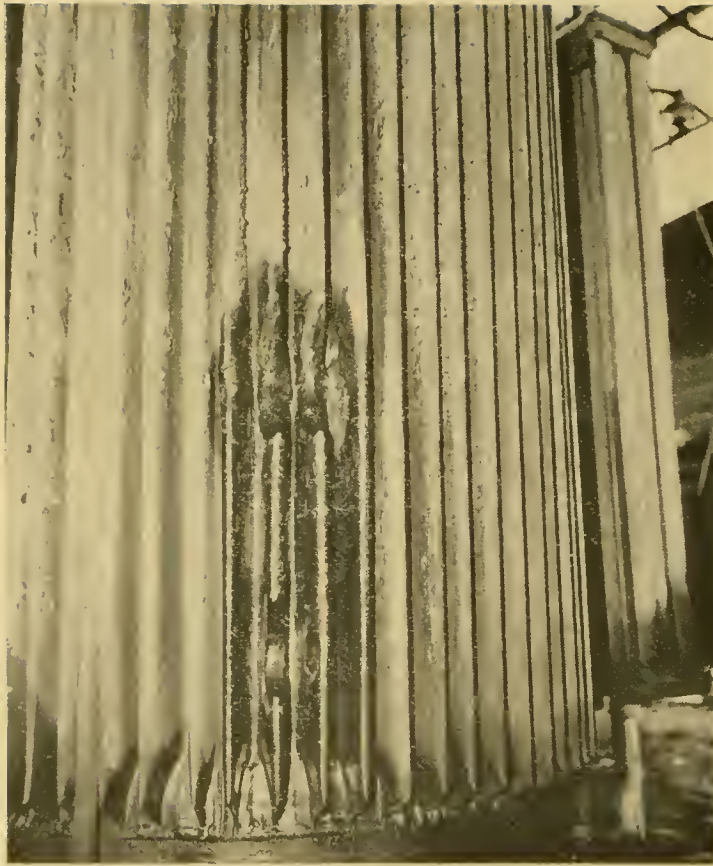
Photo 30—Ozaku substation—Example of welding repairs to transformer tank penetrated by 50-cal bullets. No fire had occurred

*Recuperability*—The company promptly moved spare transformers in the bank in place of the ones damaged by fire. While this moving was going on, a very ingenious job of electric welding was done on the punctured transformers. (Exhibit A, photo 30) All the holes were closed and the oil replaced. The station was out of service three days.

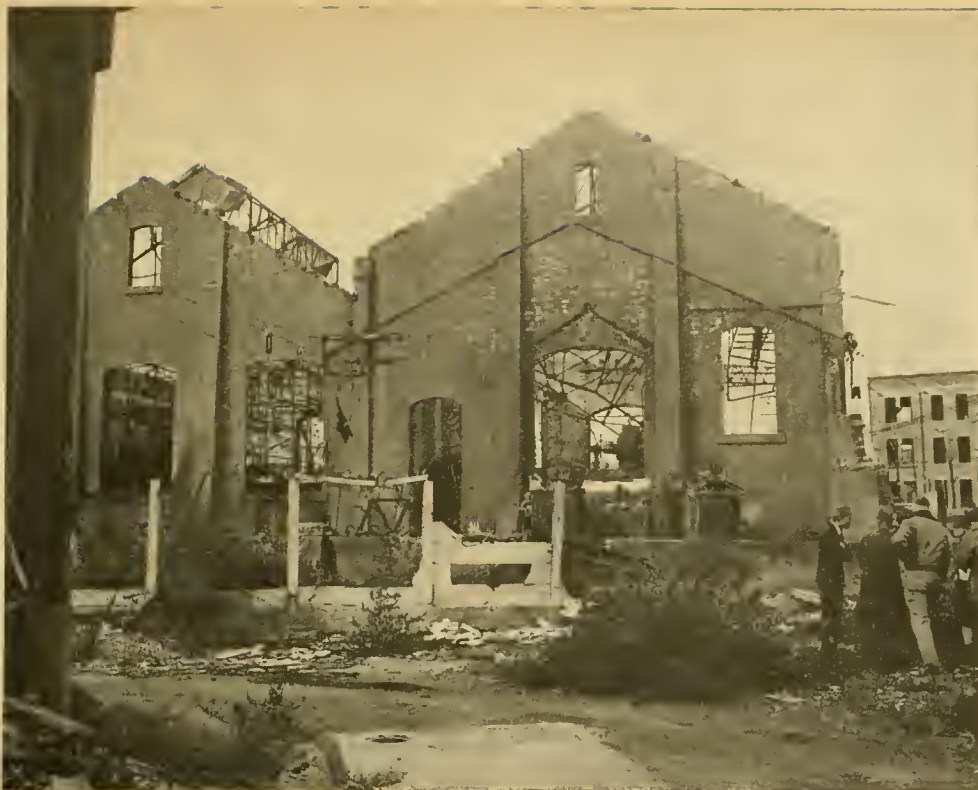
*Principal physical damage*—The HE did considerable damage to the building, but practically none to the electrical equipment. The IBs dropped on the adjacent area started fires that spread to the substation. The fire completely destroyed all the electrical equipment and the station is beyond repair. (Exhibit A, photos 31, 32 and 33)

Photo 31—Sugamo substation—Front view of building—transformer and regulator storage yard in foreground

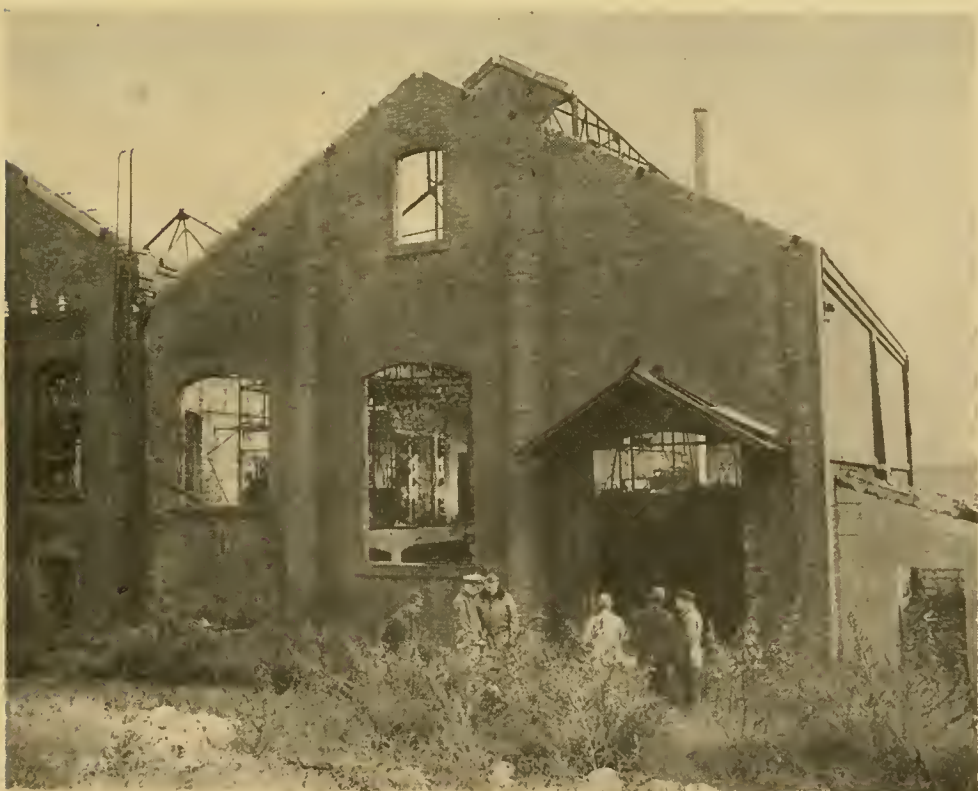
Photo 32—Sugamo substation—Rear view of building. Transformers and switch-board showing are completely destroyed
